INVESTIGATION OF VSTOL AIRCRAFT ENGINE SURGE DUE TO GROUND VORTEX INGESTION

J. Lepicovsky

A. A. duPont

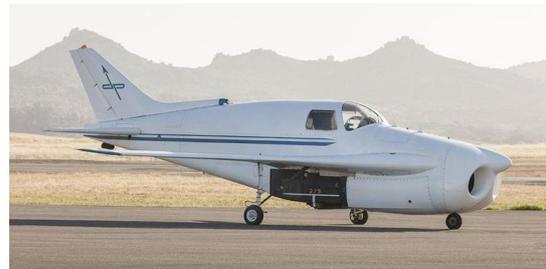
Figure 1: Aircraft DP-1C (side view)

The duPont Aerospace DP-1C aircraft was a 53% scale prototype demonstrator for a fixed-wing vertical/short-takeoff-and-landing (VSTOL) small transport airplane (Figs. 1 and 2). The aircraft was intended for high subsonic speeds with a uniquely designed jet vectored thrust allowing VSTOL capability (duPont & Reuss, 2003). Two Pratt & Whitney Canada 530A turbofan engines powered the aircraft. The engines were located side-by-side in the front fuselage past inlet ducts. Engine exit nozzle flows were separately vectored for 90 deg by pivoted airfoil cascades located in the fuselage center of gravity to facilitate transition from the

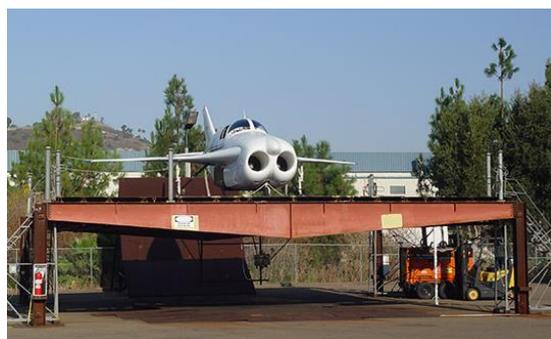
Figure 4: Elevate test platform

Initial tests of the thrust vectoring device were performed on a mesh platform elevated 3 m above the ground (Fig. 4). However, later when the aircraft was tested on the ground the engines stalled during run ups. These pop stalls occurred

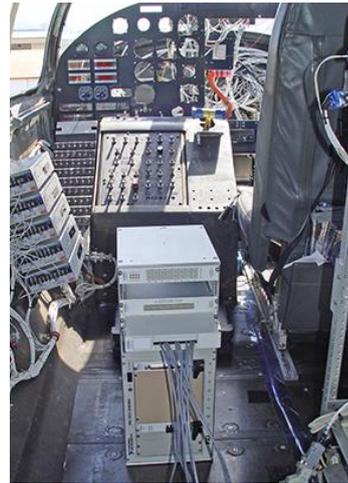
Figure 11: On-board main data acquisition unit

The layout of the experimental arrangement is shown in Fig. 9, including the labels of individual components. An overall view of the test site is illustrated in Fig. 10. The data acquisition unit was located on board the aircraft and was connected to the main computer in the control station via a fiber optics link. A view of the onboard unit, located behind the pilot seat, is presented in Fig. 11.

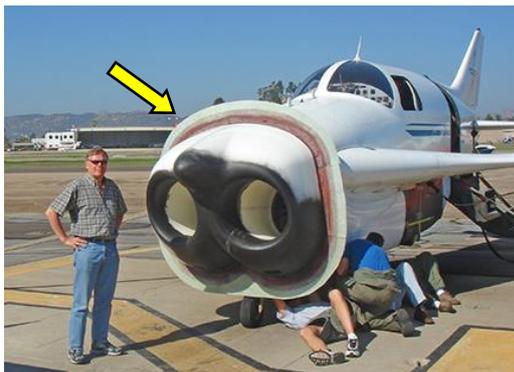
Figure 18: Collar flow deflector

It appeared that a possible remedy might be modifications of the flow pattern ahead of the inlet lips (Saripalli et al., 1997). Extensive smoke and tufts flow visualization ahead of the aircraft inlets were carried out for several flow deflector configurations. A collar around the fuselage front part as shown in Fig. 18, proved not to be effective at all. On the other hand retractable double scoop flow deflector, hinged at the front fuselage under the inlet lips (Fig. 19, proved very successful.

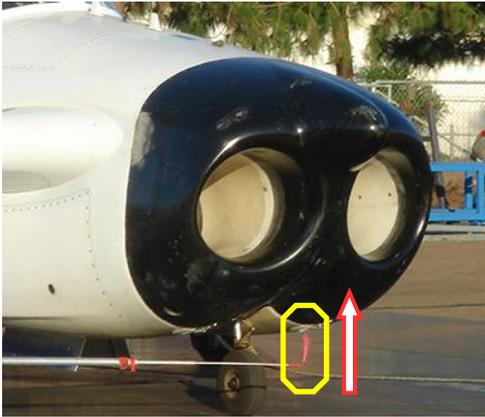
Figure 20: Prevailing flow at ground level no flow deflector

Extensive smoke and tufts flow visualization around the engine inlets indicated significant changes in the overall flow pattern. Results of these tests are summarized in Figs. 20 through 23. In each figure a bundle of tufts attached to a long stick is encircled by a yellow oval for better visibility; next to it is a red arrow indicating the prevailing flow direction in a given station in front of the inlets. As seen in Fig. 20, for no deflector, the flow arrow points vertically from the ground directly into the inlets, which result in engine stalls.

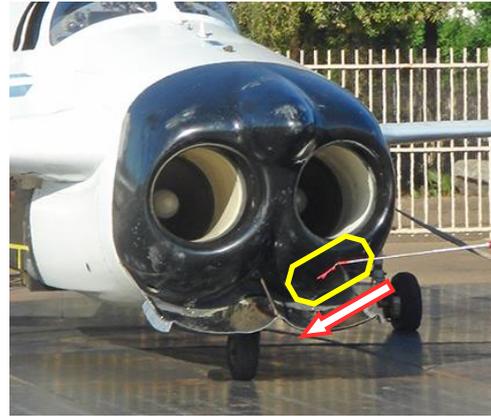
Figure 22: Prevailing flow at inlet lip level; scoop flow deflector deployed

The situation is significantly different for the deployed scoop deflector. At the ground level (Fig. 21), there is a strong flow in the forward direction. It appears that at the inlet lower lip station (Fig. 22), the flow is turning towards the inlets. Finally, at the mid inlet station (Fig. 23) the flow rushes directly into the engine inlet.
